NASA/CR—2002-211687

# Recent Developments in the Environmental Durability of SiC/SiC Composites

Linus U.J.T. Ogbuji  
QSS Group, Inc., Cleveland, Ohio

Prepared for the  
CIMTEC 2002, International Conferences on Modern Materials and Technologies  
cosponsored by the Academy of Ceramics, the International Ceramic Federation, and  
the International Union of Materials Research Societies  
Florence, Italy, July 14–19, 2002

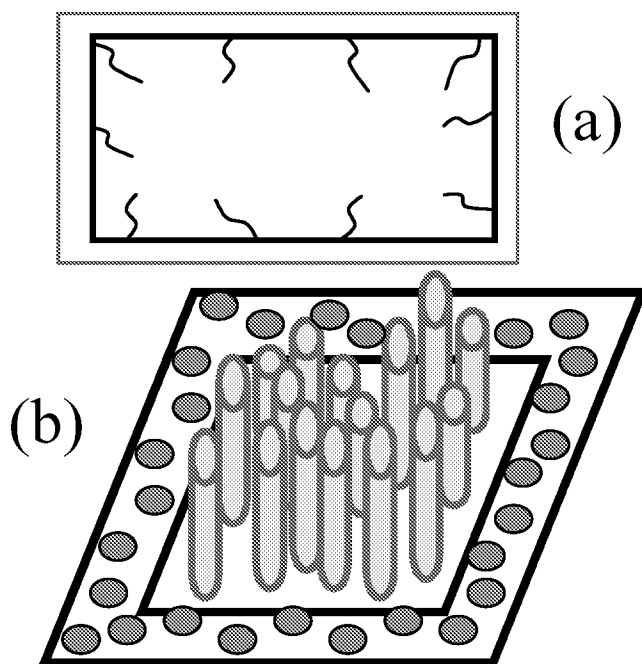
Fig. 1.—Schematic illustration of the origin and fracture features in Type I pest.

Figure 1 illustrates Type I pest. Surface-intersecting cracks facilitate ingress of oxidants to the sample interior and thus promote pest. In SiC/BN/SiC the interphase BN coating on the fibers can itself constitute a pathway for oxidant ingress when fiber ends become exposed. Type I pest in SiC/BN/SiC is caused by permeation of oxidation along those routes. The fracture surface has a “picture frame” appearance,<sup>5</sup> which is illustrated in Fig. 1(b). The “picture” is a core of undamaged material characterized by pull-out of fibers, and the surrounding “frame” is a brittle-fracture zone of damaged material. In SiC/BN/SiC, advance of the damage front correlates with recession of the interphase as it is attacked by ambient oxidants.<sup>6</sup> Hence, Type I pest degradation is time-dependent, like fatigue or creep, and should be amenable to modeling for lifetime prediction. The residual strength of a SiC/SiC tensile bar undergoing a Type I pest is proportional to the cross-sectional area of undamaged material at the core.<sup>3,5</sup> Type I pest is relatively slow, being controlled by the consumption of BN interphase. A primary cause of Type I pest is the intrinsically inadequate oxidation resistance of the BN interphase.

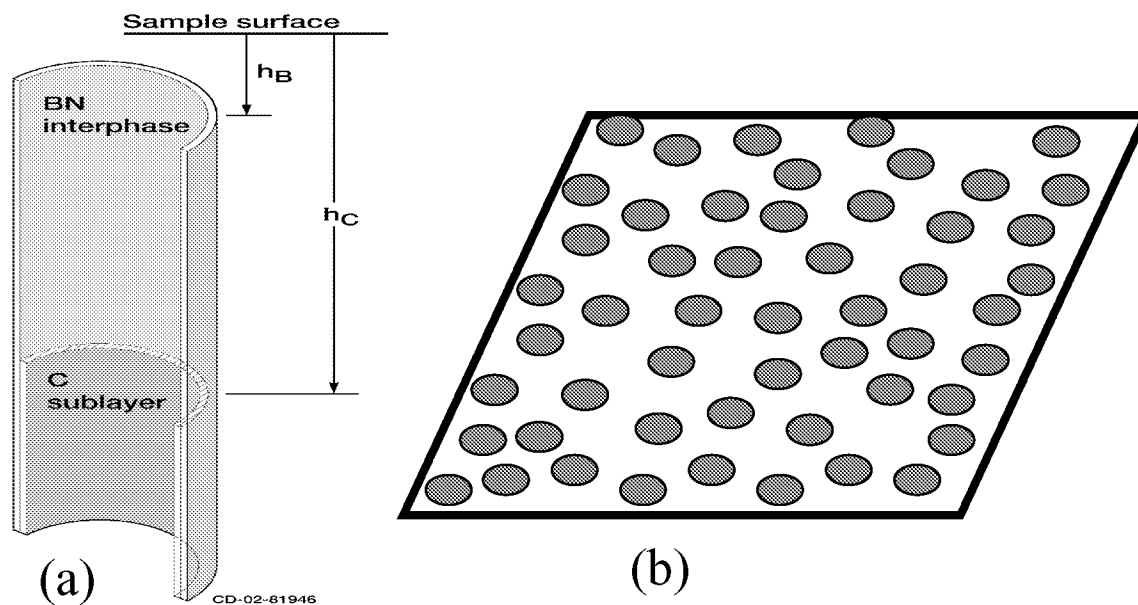
Fig. 2.—Schematics of Type II pest in SiC/BN/SiC: (a) its origin in an interphase sub-layer of carbon; (b) its manifestation in flat and brittle tensile fracture across the sample.

Types I and II pest is best understood with reference to Fig. 2(a). A fiber (omitted for clarity) is separated from its BN interphase coating by a film of carbon. Upon exposure to the ambient, the BN presents a cross-sectional area  $\pi r^2 t_B$  to the flame (where  $r$  is radius of the coated fiber and  $t$  thickness of the BN layer). Oxidation causes the BN to recede to a depth  $h_B$ ; in the absence of the carbon layer this amounts to Type I pest. When the carbon film is present it recedes to a greater depth,  $h_C$ , thus exposing the BN to additional oxidation on its inner wall facing the fiber. This additional attack on the BN wall, area  $2\pi r(h_C - h_B)$ , is the hallmark of Type II pest: it does not occur in Type I pest.

Since  $r$  and  $t$  are measured in micrometers while  $h_C$  is measured in centimeters (being typically the sample width<sup>1,7</sup>), the area of BN attack in Type II pest is vastly larger than in Type I. Consequently, degradation of Type II pest reaches deep into the material interior very quickly. A big difference between the two types, then, is the speed of attack: Type I correlates with the linear recession of the BN interphase (which is slowed down by the borosilicate from BN oxidation<sup>5</sup>), while Type II follows a short-circuit path of adventitious carbon and destroys the material very quickly.<sup>1</sup> Also, a tensile specimen under Type II pest fails like a monolithic ceramic, with fracture occurring all in one crack plane, as illustrated in Fig. 2(b).

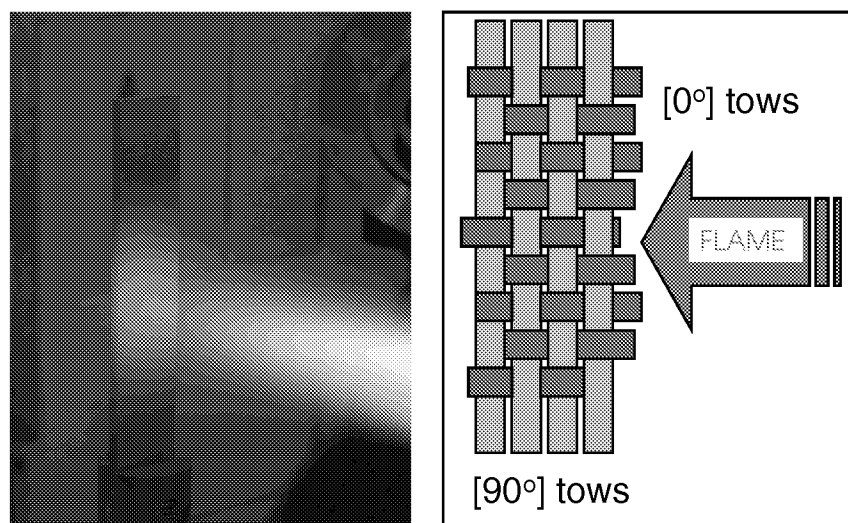
Fig. 3.—Testing for Pest in  $\text{SiC}/\text{SiC}$ : Left, a sample in the APBR flame; Right, the Schematic details of sample architecture.

Our test for  $\text{SiC}/\text{SiC}$  pest susceptibility is to expose a sample in an atmospheric-pressure burner rig (APBR) flame, and then measure its residual tensile response. The material is a tensile bar, with fiber ends and their associated coatings exposed along the machined edge. The picture shows a sample in the APBR flame, while the schematics illustrate relevant details of its architecture. The fibers on whose ends the flame impinges are designated  $[0^\circ]$  fibers, for distinction from the  $[90^\circ]$  fibers, which lie in the longitudinal direction of the sample. In the absence of open matrix cracks, flame gases have no direct access to the  $[90^\circ]$  fibers and the interphase coatings around them. Since only the  $[90^\circ]$  fiber tows bear load in the subsequent tensile test, a severe reduction in fracture strength or strain implies that interphase degradation has spread quickly from the  $[0^\circ]$  to the  $[90^\circ]$  fiber tows; this is a good indicator of Type II pest.

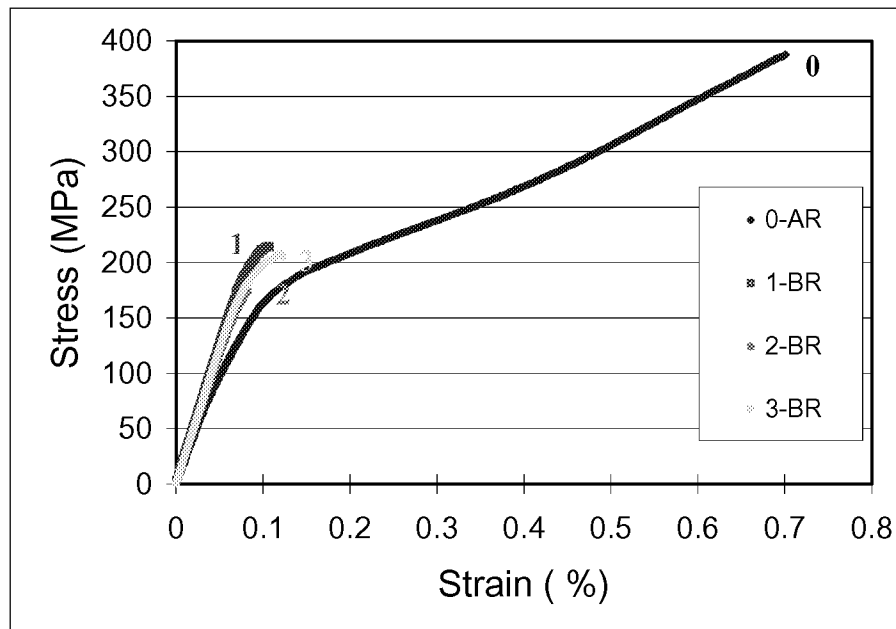
Fig. 4.—The stress-strain behavior of as-received Hi-Nicalon/BN/SiC (#0), and three samples (1–3) of the same material that underwent Type II pest in the burner rig (BR).

Figure 4 illustrates the dramatic effect of Type II pest on the mechanical properties of Hi-Nicalon™/BN/SiC materials, in which excess carbon in the fiber “sweats” out during melt-infiltration of the matrix to form a compact layer of carbon beneath the BN interphase. The residual strength and fracture strain of the three samples exposed in the burner rig are drastically diminished from those of the as-received (AR) sample. In effect, pested material fails at or just above the elastic regime, indicating that the material is behaving as a monolith rather than a composite.

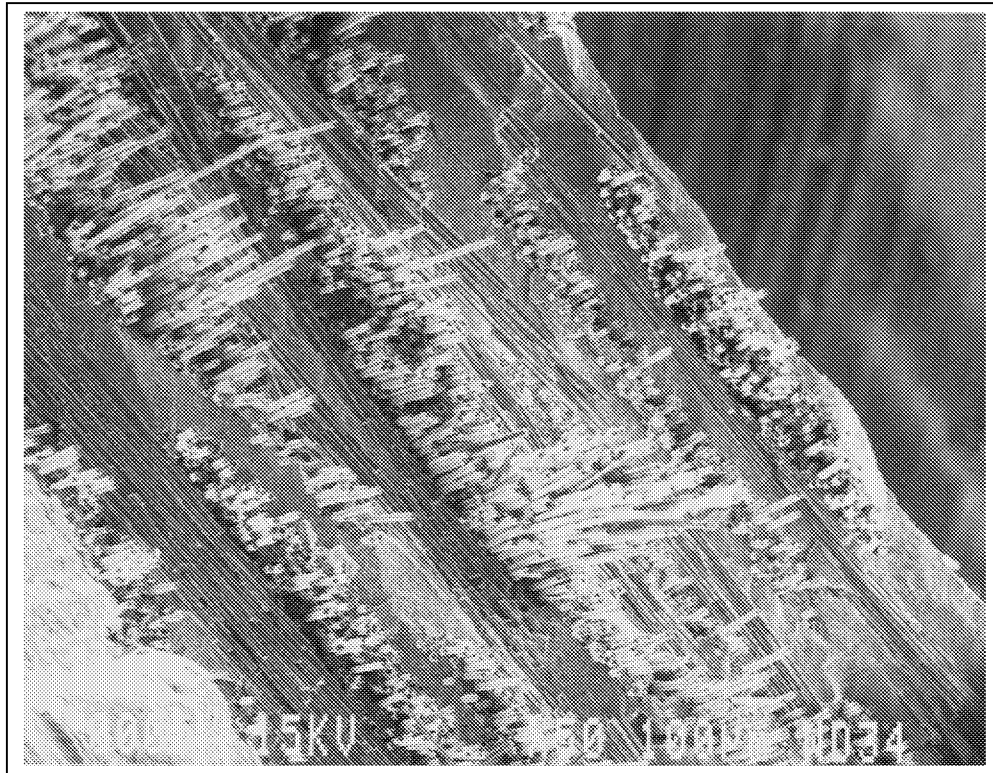
Fig. 5.—“Picture Frame” fracture surface in Hi-Nicalon™/BN/SiC exposed for 200 hours in a box furnace (room air); Type I pest is evident in brittle fracture of fibers at the edges, while the center exhibits millimeters-long fiber pull-out like the as-received material.

Figure 5 shows features of Type I pest: brittle fracture along the edge and fibrous fracture in the interior. When Hi-Nicalon™/BN/SiC bars were exposed to quasi-static room air in a box furnace (containing ~2.5% H<sub>2</sub>O), pest started at the cut edges and stepped inward, tow by tow: after 500 hours at 800 °C damage had reached the 3rd tows from each end (consuming ~15% of the cross-section). In contrast, Fig. 6 shows the more pervasive degradation that result from Type II pest. The characteristic features

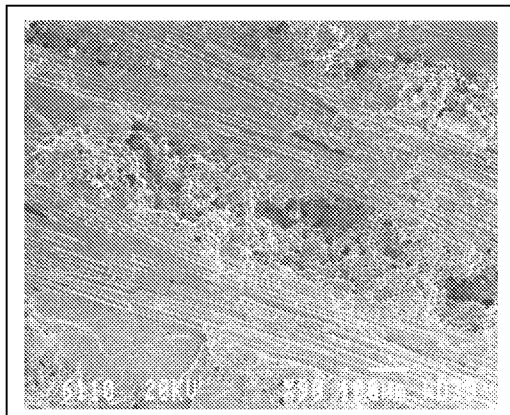
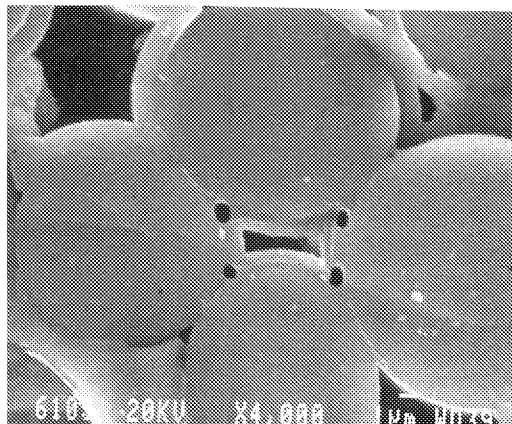
Fig. 6.—SEM micrographs of fracture surface from Hi-Nicalon™/BN/SiC exposed 150 hours in a burner rig, showing Type II pest features: (a) flat/brittle fracture throughout the sample; (b) fibers bonded together by glass, with holes between them for venting gaseous products, and fiber fracture that was typically initiated at bonding spots.

include flat fracture from edge to edge. At higher magnification, Fig. 6(b), it is evident that the fibers have become bonded together or to the matrix by silica, with prominent holes from venting the  $B(OH)_x$  volatiles from hydrolysis of borosilicates. In Hi-Nicalon™/BN/SiC, the offending free carbon came from stoichiometric excess in the fiber.

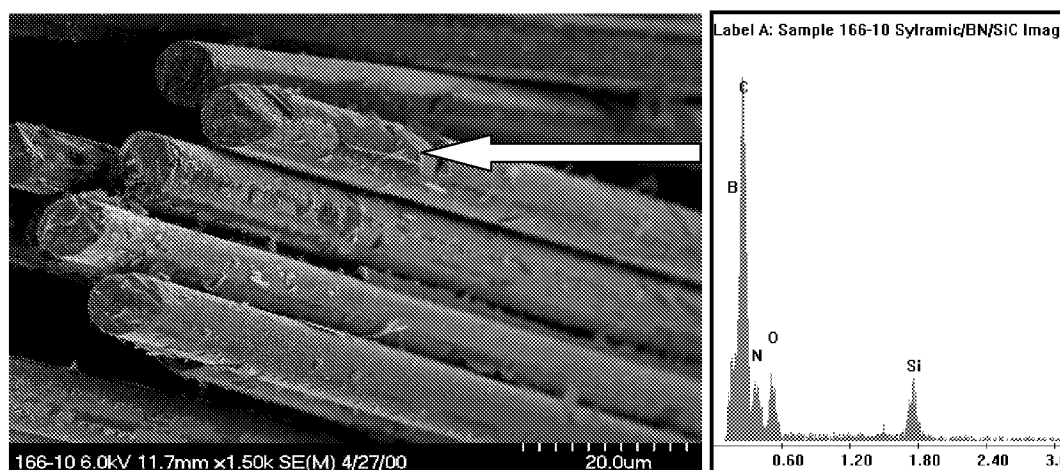
Fig. 7.—SEM micrograph of the fracture surface from as-received Sylramic™/BN/SiC showing a compact “coating” layer on the fibers; the EDS spectrum on the right identifies this layer as almost entirely carbon (from incomplete removal of sizing).

Figure 7 shows a variety of Sylramic™/BN/SiC that exhibited Type II pest, and flat fracture very similar to that in Fig. 6. The difference is that in this material (Sylramic™/BN/SiC) the offending carbon film came from substantial char residue left by the removal of fiber sizing, rather than from the fiber itself.

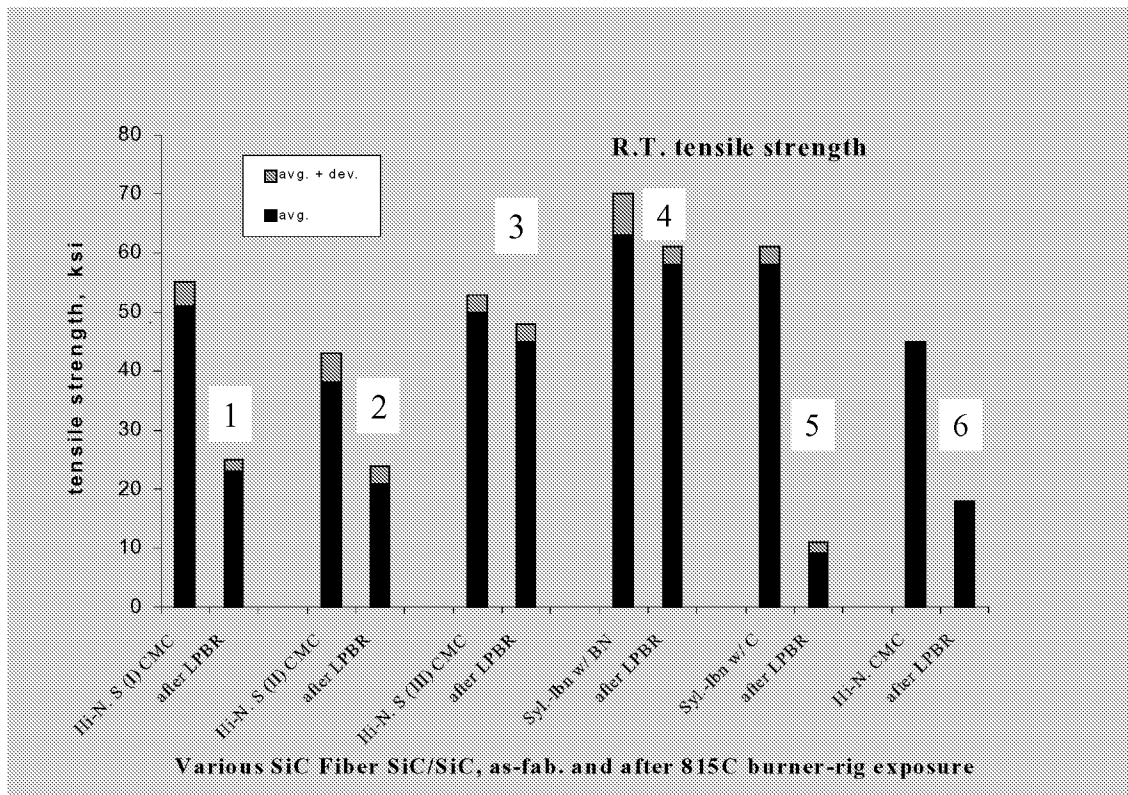
Fig. 8.—Tensile strength of various SiC/BN/SiC materials with different carbon contents, before and after exposure in the burner rig, illustrating some remedies for Type II pest (“APBR” and “LPBR” in this paper refer to the same rig: Our atmospheric-pressure burner rig is sometimes referred to as a “low-pressure burner rig”, or “LPBR.”).

Figure 8 shows the results of studies aimed at reducing or counteracting the presence of graphitic carbon in SiC/BN/SiC composites. Each histogram pair shows the strength of a specific SiC/BN/SiC vintage before and after exposure in our burner rig. Hi-Nicalon™ fiber (pair #6) contains ~40% excess carbon, which causes Type II pest. Its successor, Hi-Nicalon-S (#1), has <5% excess carbon, but our burner rig tests showed that this level of carbon was still high enough to cause Type II pest. Histogram pairs #2 and #3 illustrate the effects of further reductions in free carbon, made by the manufacturer in the case of Hi-Nicalon-S (II), or through special heat treatment in our labs (III).<sup>11</sup> Histogram #4 shows the high resistance to pest achieved in Sylramic™/BN/SiC composites by inducing *in-situ* growth of an additional BN layer through special heat treatment,<sup>12</sup> while #5 shows that such resistance is again lost when a carbon layer exists beside the *in-situ* BN.

It is clear from Fig. 8 that the most effective remedy for Type II pest is to exclude free carbon that may arise from handling or treating the constituents. In contrast, Type I pest is intrinsic, and its suppression/reduction calls for remedies that increase oxidation resistance of the interphase. These include the use of high-purity and high-temperature BN for improved crystallinity,<sup>11</sup> doping the BN with Si,<sup>6</sup> and inducing an auxiliary BN layer through in-situ treatment of the composite.<sup>13</sup>
